EXISTING CONVEYOR SYSTEM

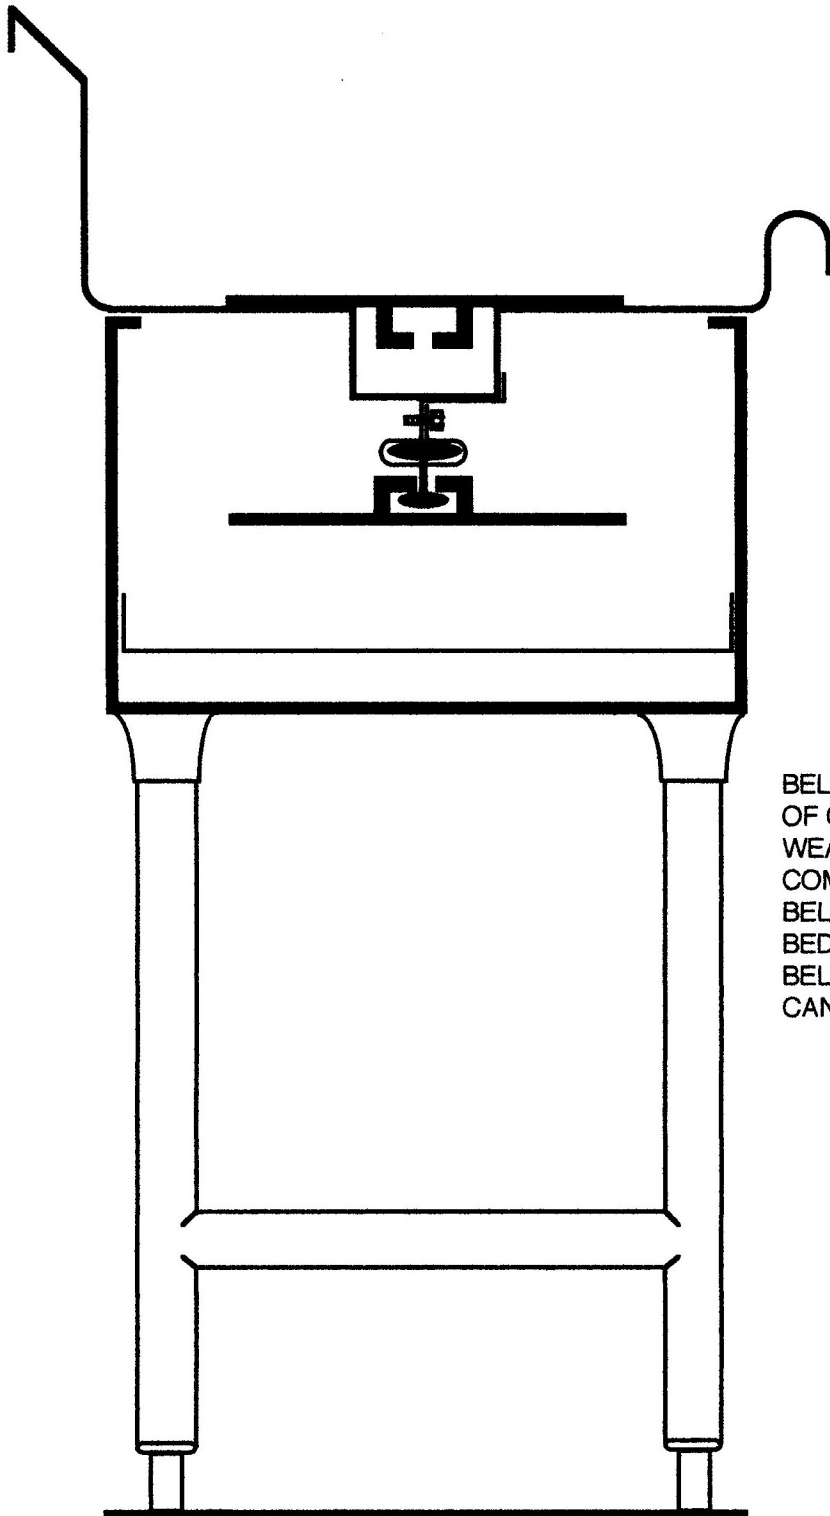
BELT IS RIDING DIRECTLY ON SLIDER BED OF CONVEYOR THIS CAUSES EXCESSIVE WEAR, MOSTLY ON SLIDER BED. SINCE COMPOUNDS IN BELT RESIST WEAR, THE BELT WILL "CUT" A GROOVE IN SLIDER-BED THE WIDTH OF THE BELT. IF YOU LIFT BELT OFF SLIDER BED THIS GROOVE CAN BE SEEN.
